JADWIN DAM

CONDITION REPORT

DAM, OUTLET WORKS & SPILLWAY
PERIODIC INSPECTION REPORT NO. 4

NOVEMBER 1980

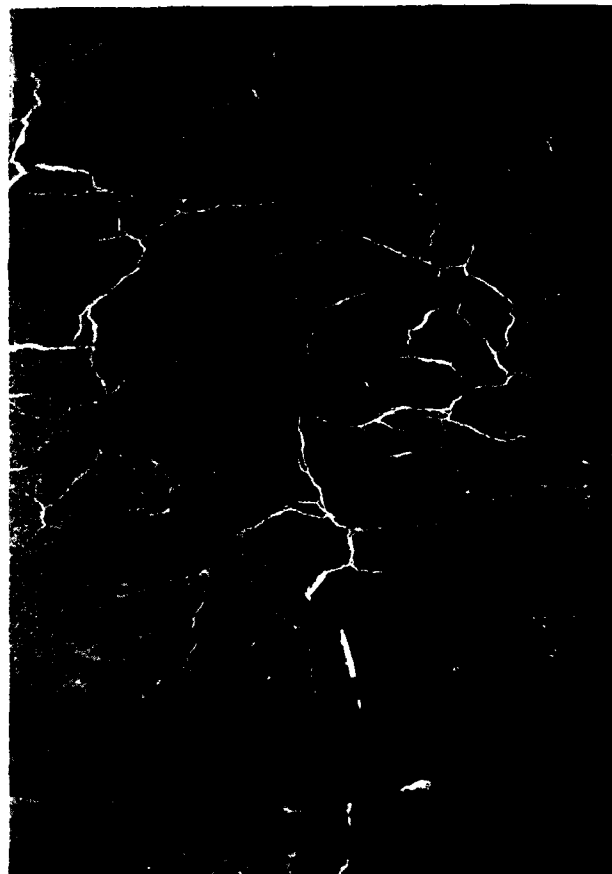
a. Weir. Considerable surface deterioration of concrete including cracking and spalling at the top and downstream portion of the ogee. Extensive cracking varying from hairline to $\frac{1}{4}$ inch width at top of the ogee noted. Recommend sealing of the wider cracks (larger than $\frac{1}{32}$ inch).

Photo No. 9. Cracking in top of ogee weir.

c. The second monolith from the left (looking downstream) has experienced more substantial cracks in the crest which should be sealed as they will lead to substantial spalling of the crest (cracks generally run in a pattern which parallels the long axis of the weir).
